St. Joseph's Apache Mission Restoration Project

Illustrated Progress Report: Summer 1999

St. Joseph Apache Mission Restoration Project Progress Report: Summer 1999

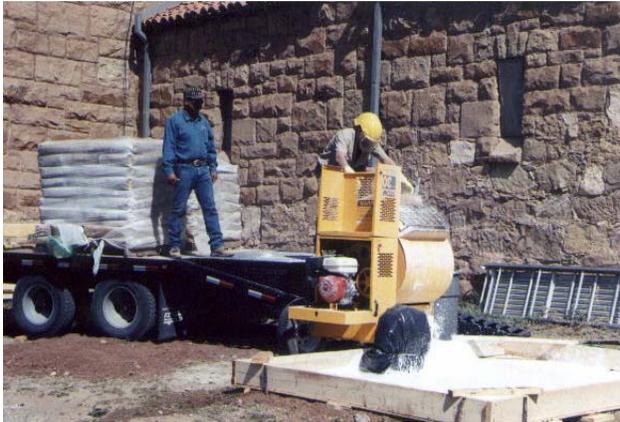
Ernest Martinez and Pete Mold mix high calcium hydrated lime into lime putty.

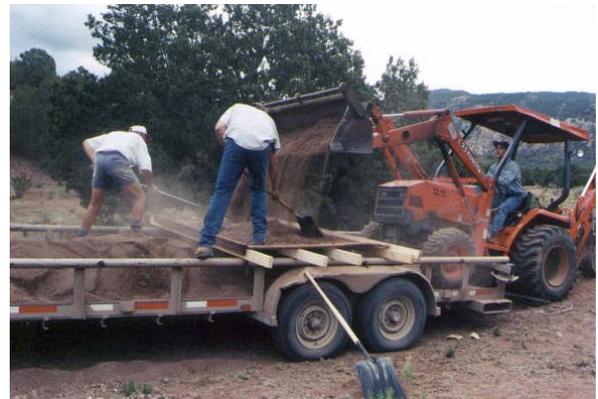
Sand from Saenz Family arroyo in Bent, NM collected and sieved. Richard and Estefana Saenz have offered to donate all the sand necessary for the restoration of St. Joseph's Apache Mission church.

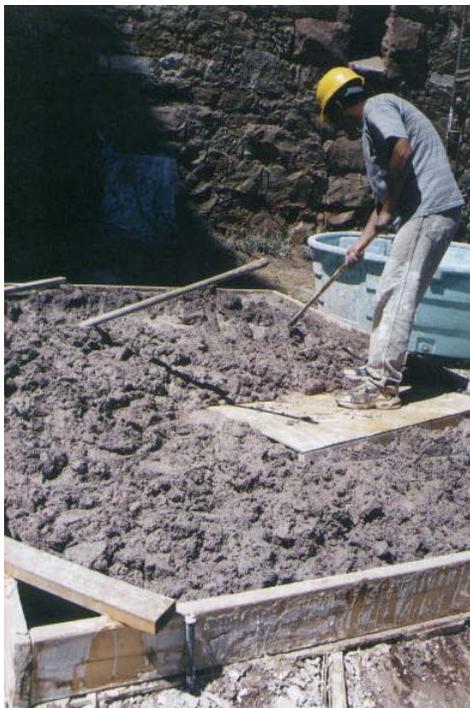
Lime putty and sand was mixed together in a wooden bin, then transferred into a plastic bin and covered with plastic sheeting for storage.

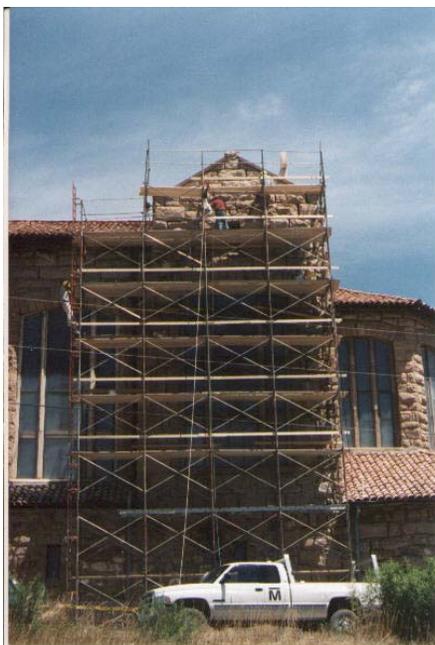
Rented scaffolding provided access to the wall. The work of re-mortaring began at the top and proceeded downward. We will investigate the feasibility of purchasing scaffolding for future work.

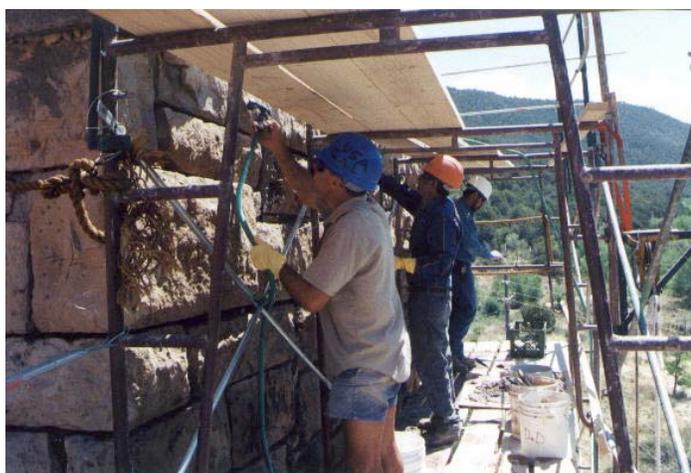
The mortar joints are cleaned, scrubbed, and then wet down before new mortar is applied.

Scaffolding was erected on the face of one of the most deteriorated sections of wall: the south transept exterior end. On May 17, 1999 the entire crew began work on the church. The first job was to prepare the mortar joints by removing loose mortar and brushing away dirt and organic material. It was interesting to see that the original mortar had endured the elements quite well in places, and had been washed away in other places. We noticed that in areas where much of the mortar had washed away the remaining mortar had large lumps of lime, indicating that the lime and aggregate had not been well mixed. A good lesson to learn. After cleaning the mortar joints for two days the application process of new mortar began. During this application process we made of videotape of Mr. Mold demonstrating the re-mortaring technique. This video turned out quite well, and will be a valuable resource in the future.

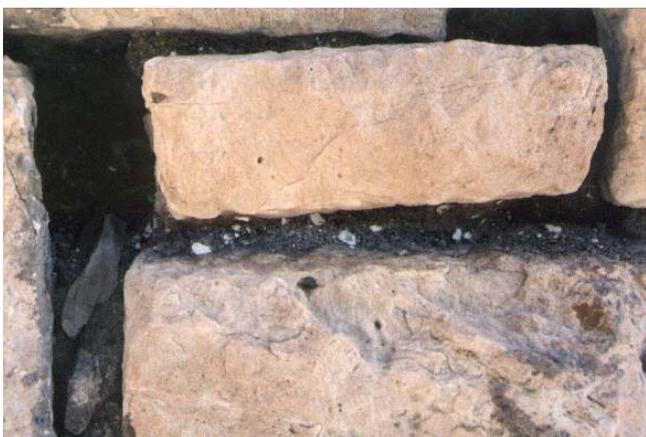
A great deal of mortar has washed away over the years. Lumps of white lime indicate areas where the sand and lime was not well mixed in some of the original mortar.

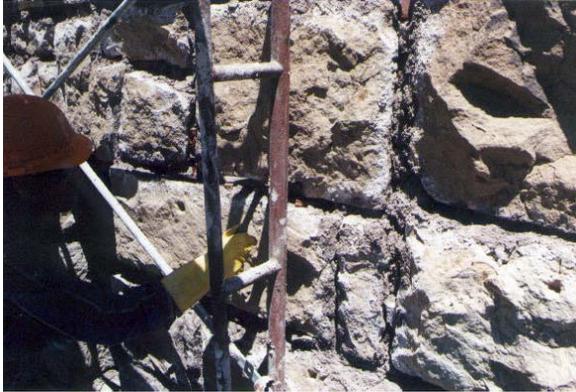
Lime mortar is pushed into joints using various trowels, and even hands. Small pieces of clay roof tile were pushed into wet mortar to add strength and limit cracking.

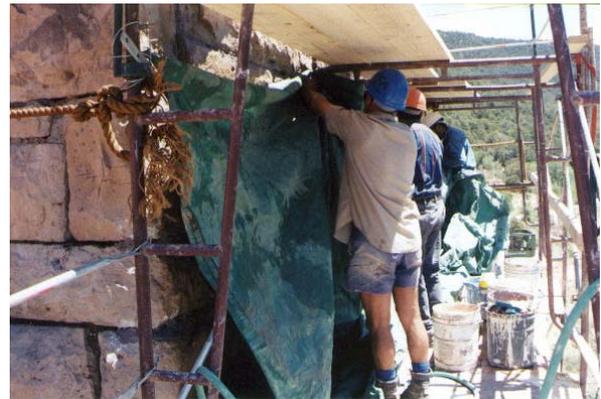
Tarps were used to protect wet mortar from sun and wind. Mortar must dry slowly for a strong, thorough cure.

mortar must be regularly moistened to ensure a slow and thorough cure. Plastic tarps were used to cover the drying mortar. It was determined that using some type of tarp to enclose the entire working area, scaffolding and all, would save time and provide a better environment for the curing process.

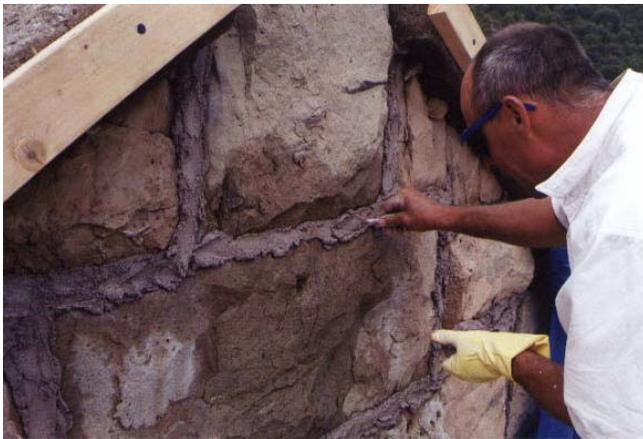
Mortar is applied in layers, depending on the depth of the joint. The top layer is “over applied” then scraped back after several hours of drying. Scraping back the top layer results in a flat surface that will allow rainwater to freely run off the wall. The exposed sand gives the mortar joint an attractive texture and color.
