St. Joseph's Apache Mission Restoration Project
illustrated Progress Report: Spring 2000

St. Joseph's Apache Mission Restoration Project Progress Report for Spring 2000

April 29, 2000

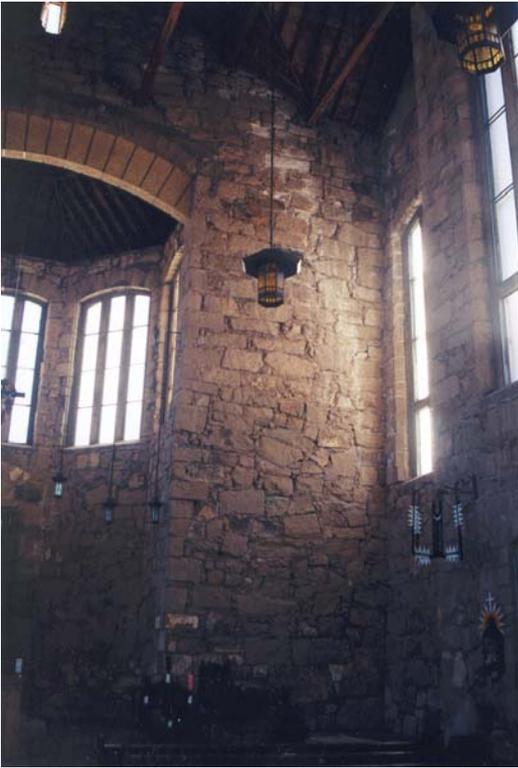
The south transept of St. Joseph's Apache Mission. This area has some of the most severe interior deterioration. Bits of rock and old mortar fall from the wall regularly.

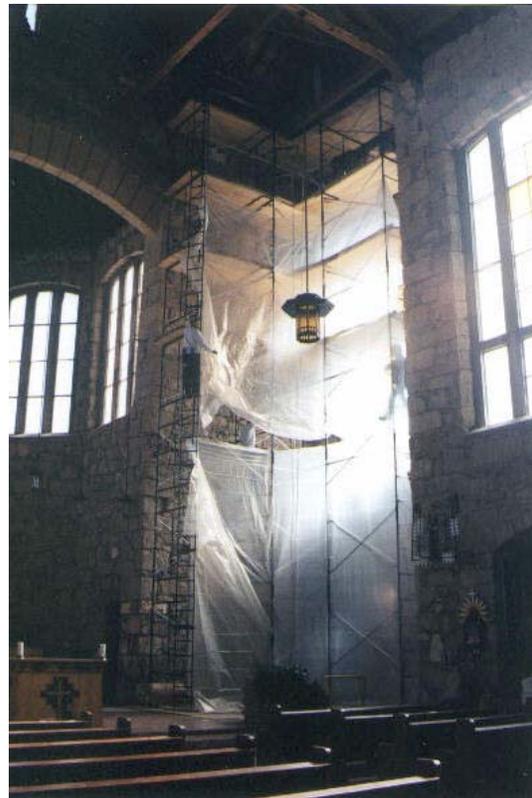
Scaffolding erected in December 1999. This scaffolding has been purchased, and will be used throughout the restoration project.

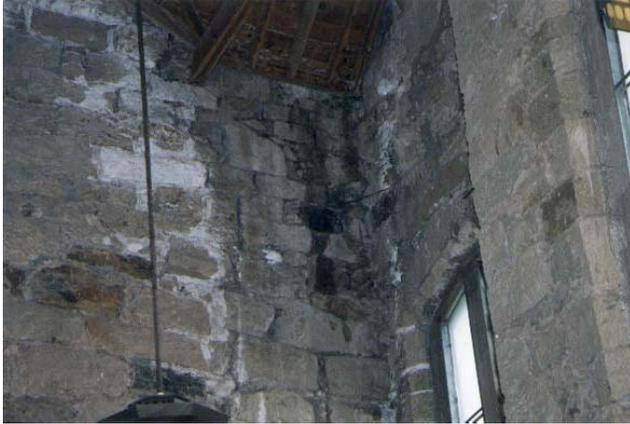
For many years water leaked through the roof, causing serious damage to this wall. This leak was repaired several years ago, now we are repairing the damage.

The water has caused the lime to separate from the mortar leaving loose, powder-like lime deposits on the surface and loose sand in the mortar joints.

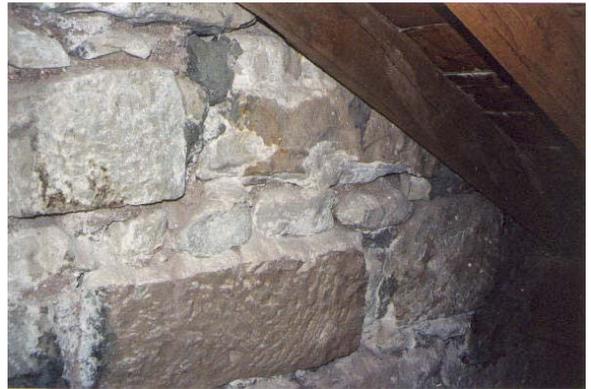
After cleaning out the loose mortar and small stones. This is a place bats had access to the interior. Note the spot of blue sky seen through this 3 foot thick wall.

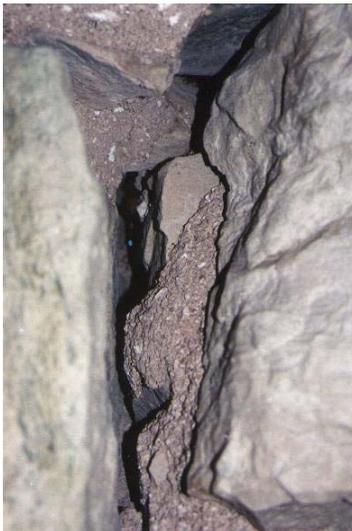
An old water leak caused this damage, washing out the mortar and actually causing the face of this stone to separate. This particular stone is located approximately 30 feet above the sanctuary floor. The stone face came off easily when we pulled it away.

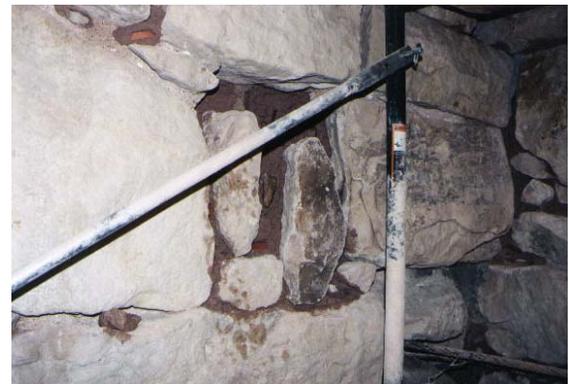
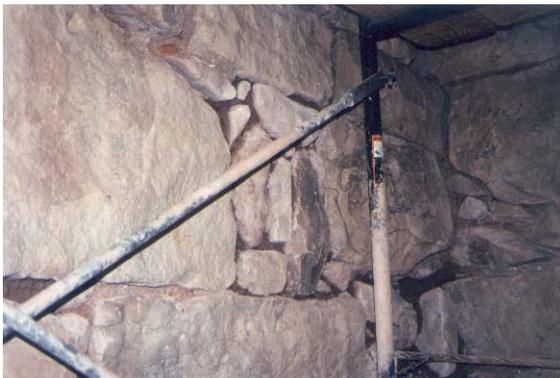
The wall has been rebuilt. After some additional curing time the stonework can be repointed.

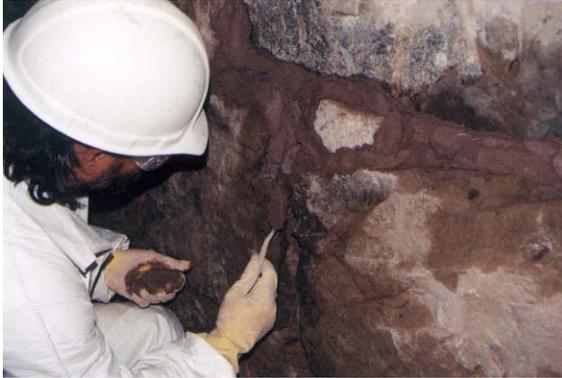
Repointing the stonework. The spaces between the stones are filled with mortar. Various tools are used to apply the mortar depending on the width of the mortar joint.

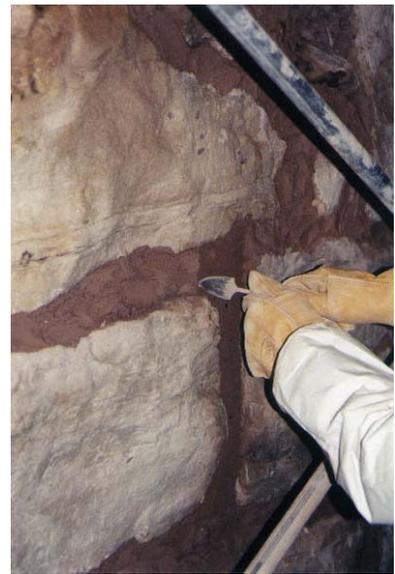
After allowing the mortar is partially dry or “cure” the surface of the mortar is scraped away. This technique produces a nicely textured, even mortar joint.
