St. Joseph Apache Mission Restoration Project

Illustrated Progress Report for November 2007 through April 2008

Progress Report

November 2007 - April 2008

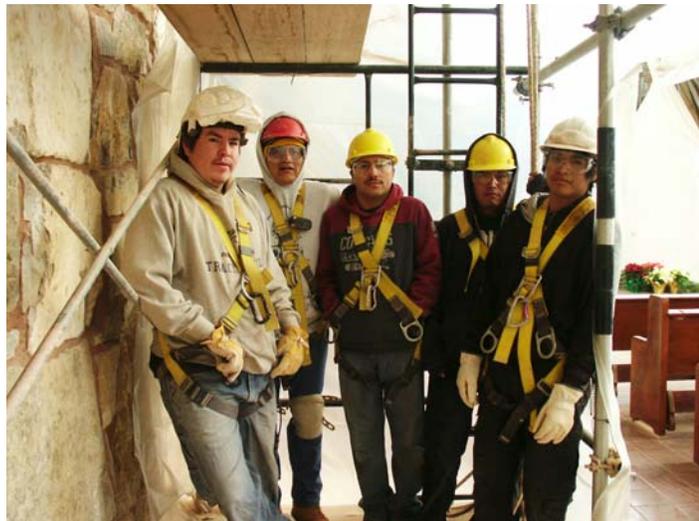
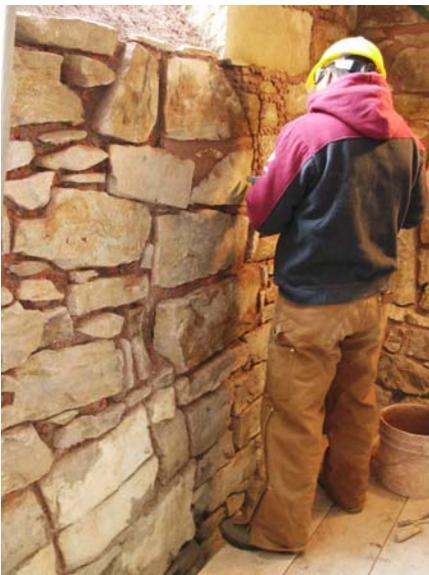
The first order of business was to repoint the stonework of the small room in the north wall that was intended to house a staircase to the choir loft. Since the choir loft was never built, this room never got a staircase. This room was being used as a counseling room and for storage. This little room measures about 15 feet by 8 feet and is 27 feet tall.

Since our last report (November 2007) the main focus of the restoration work has been repointing the stonework of the north wall interior. A great deal of work has been accomplished; the north wall interior and the “choir loft staircase room” have been finished. Still to be repointed are two of the small alcoves on this side of the church. While the scaffolding was in place on this wall the big windows were repaired – cracked glass replaced, the window framework cleaned and repainted, open gaps caulked.

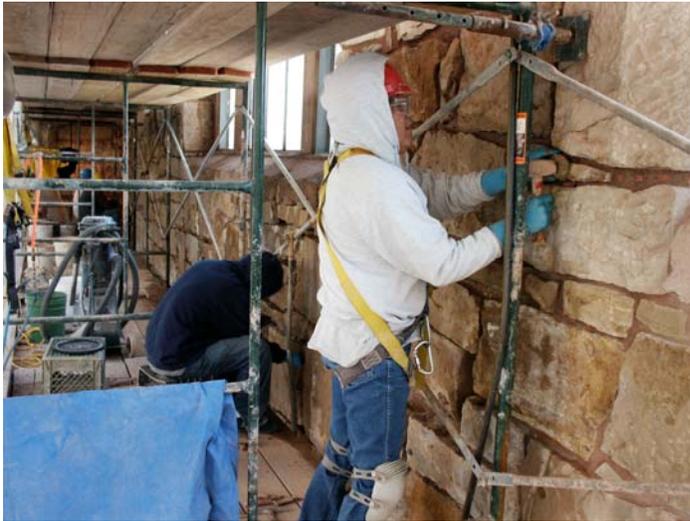
The Restoration Crew repointing the stonework of the north wall interior.

The repointing process involves the following steps: First deteriorated mortar is removed, usually digging into the mortar joints one to two inches. In places we have found that the mortar is so weak it is necessary to remove a foot or more into the wall. This step also involves removing smaller stones no longer stable. The next step is to give the mortar joints and the face of the stones a good cleaning with a scrub brush and water. After the stones are clean from dust and grime a “base coat” of mortar is applied, filling in the deeper holes and resetting the smaller stones that had to be removed.

to cure (harden), a “top coat” of mortar is applied. Once the top coat cures for a day or two the surface of the top coat is scraped back using the edge of a sharp trowel so that the finished surface of the mortar flows smoothly between the stones without tool marks, thereby exposing the sand to provide an attractive color and texture.

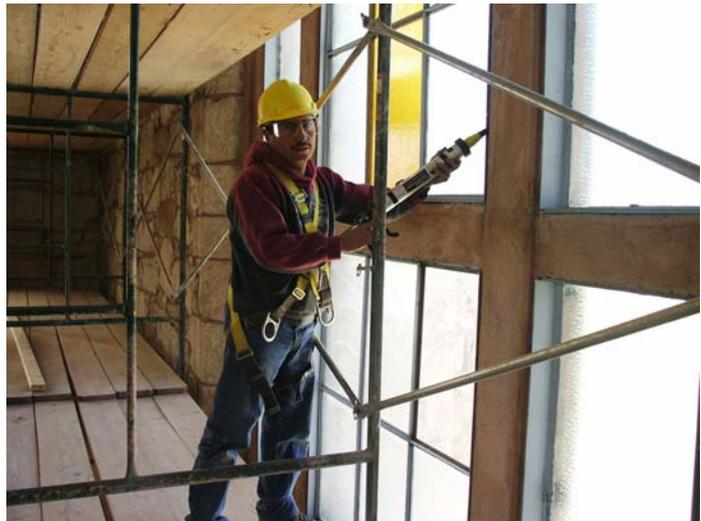
Martin Pizarro caulking gaps in the window frame to keep the cold wind out.

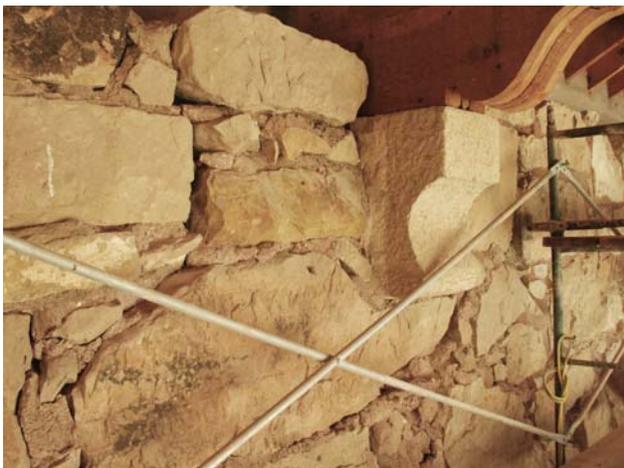
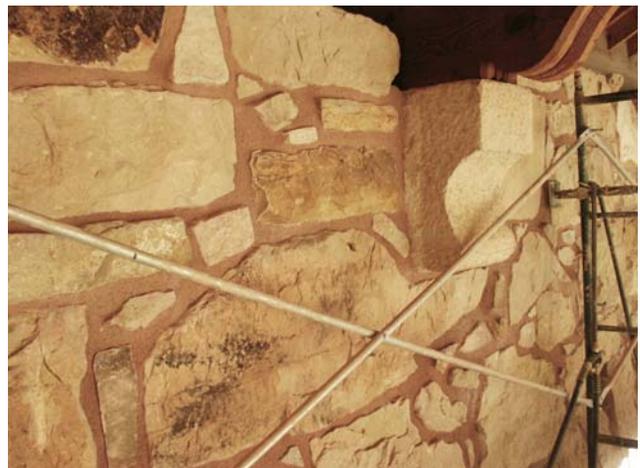
Here is a demonstration of “Before” and “After” our repointing work at the top of the north wall interior.

There is a great deal of art to this repointing work, and like any art it requires patience and craftsmanship. The guys on our restoration crew excel in this ancient and noble craft. The **Chemical Lime Company** has donated all the lime we have used for this restoration project. The nice red-colored sand for our mortar has been donated by the family of Richard Saenz, Sr. in Bent, NM. The sand is hauled to the church courtesy of the **Mescalero Apache Tribe**. The attached “Illustrated Project Report” contains a “Before” and “After” photo to show the difference our repointing has made.

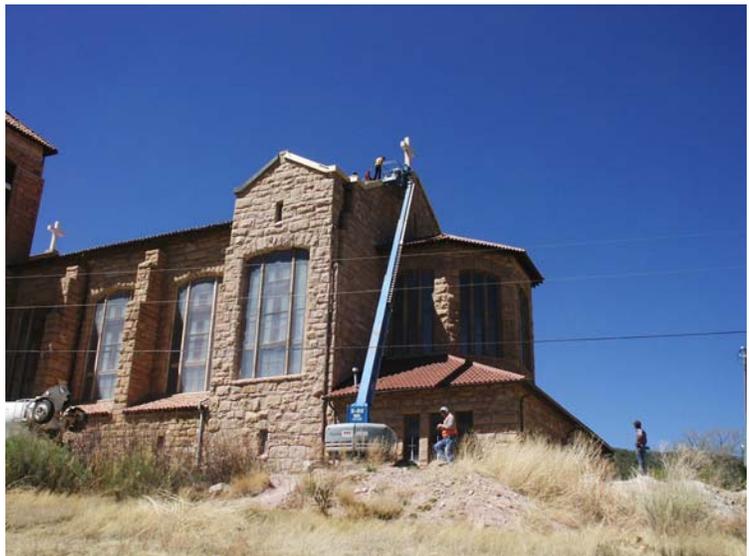
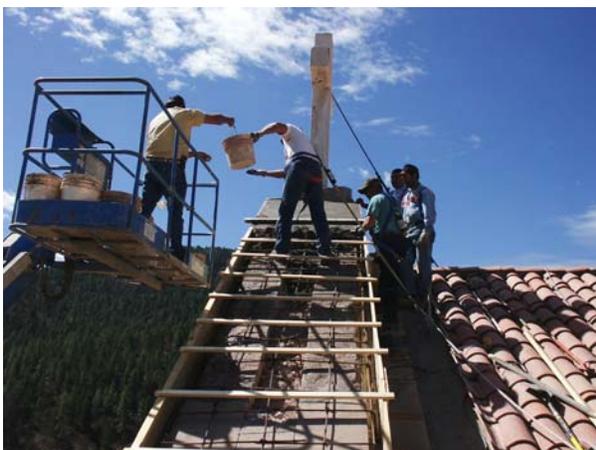
We discovered that rainwater was leaking into the church through the deteriorated concrete cornices at the top of the stone walls.

One of the major challenges facing this restoration project is the need to replace the roof. The wood of the roof is still in very good condition, but the clay tiles, the underlayment, the flashing and the roofing nails have all come to the end of their serviceable life. Last summer we enjoyed a particularly wet “monsoon” season, which clearly highlighted the need to address this problem. Leaks through the roof caused some damage to a few areas of stonework that have already been restored. Extensive testing with a water hose up on the roof helped us determine that some of the worst leaks were being caused by water penetrating through the concrete cornices at the top of the stone walls. While there are no obvious open cracks in the cornices, water has been finding a way through this old concrete.

Bar-M Construction, Inc. of La Luz, NM has been hired to install new concrete cornices.

To address this problem we hired **Bar-M Construction, Inc.** of La Luz, NM to construct new concrete cornices. Ernest Martinez, owner of **Bar-M Construction**, brought together an experienced crew of concrete workers to take on this challenging job. The proceeds from last years Restoration Raffle will pay for a portion of this work.
